March 26, 2024

**SUBJECT: *Existing Conditions Stream & Streambank Structure Assessment*
Howell Creek Streambank Stabilization/Restoration
City of Winter Park, Orange County, Florida**

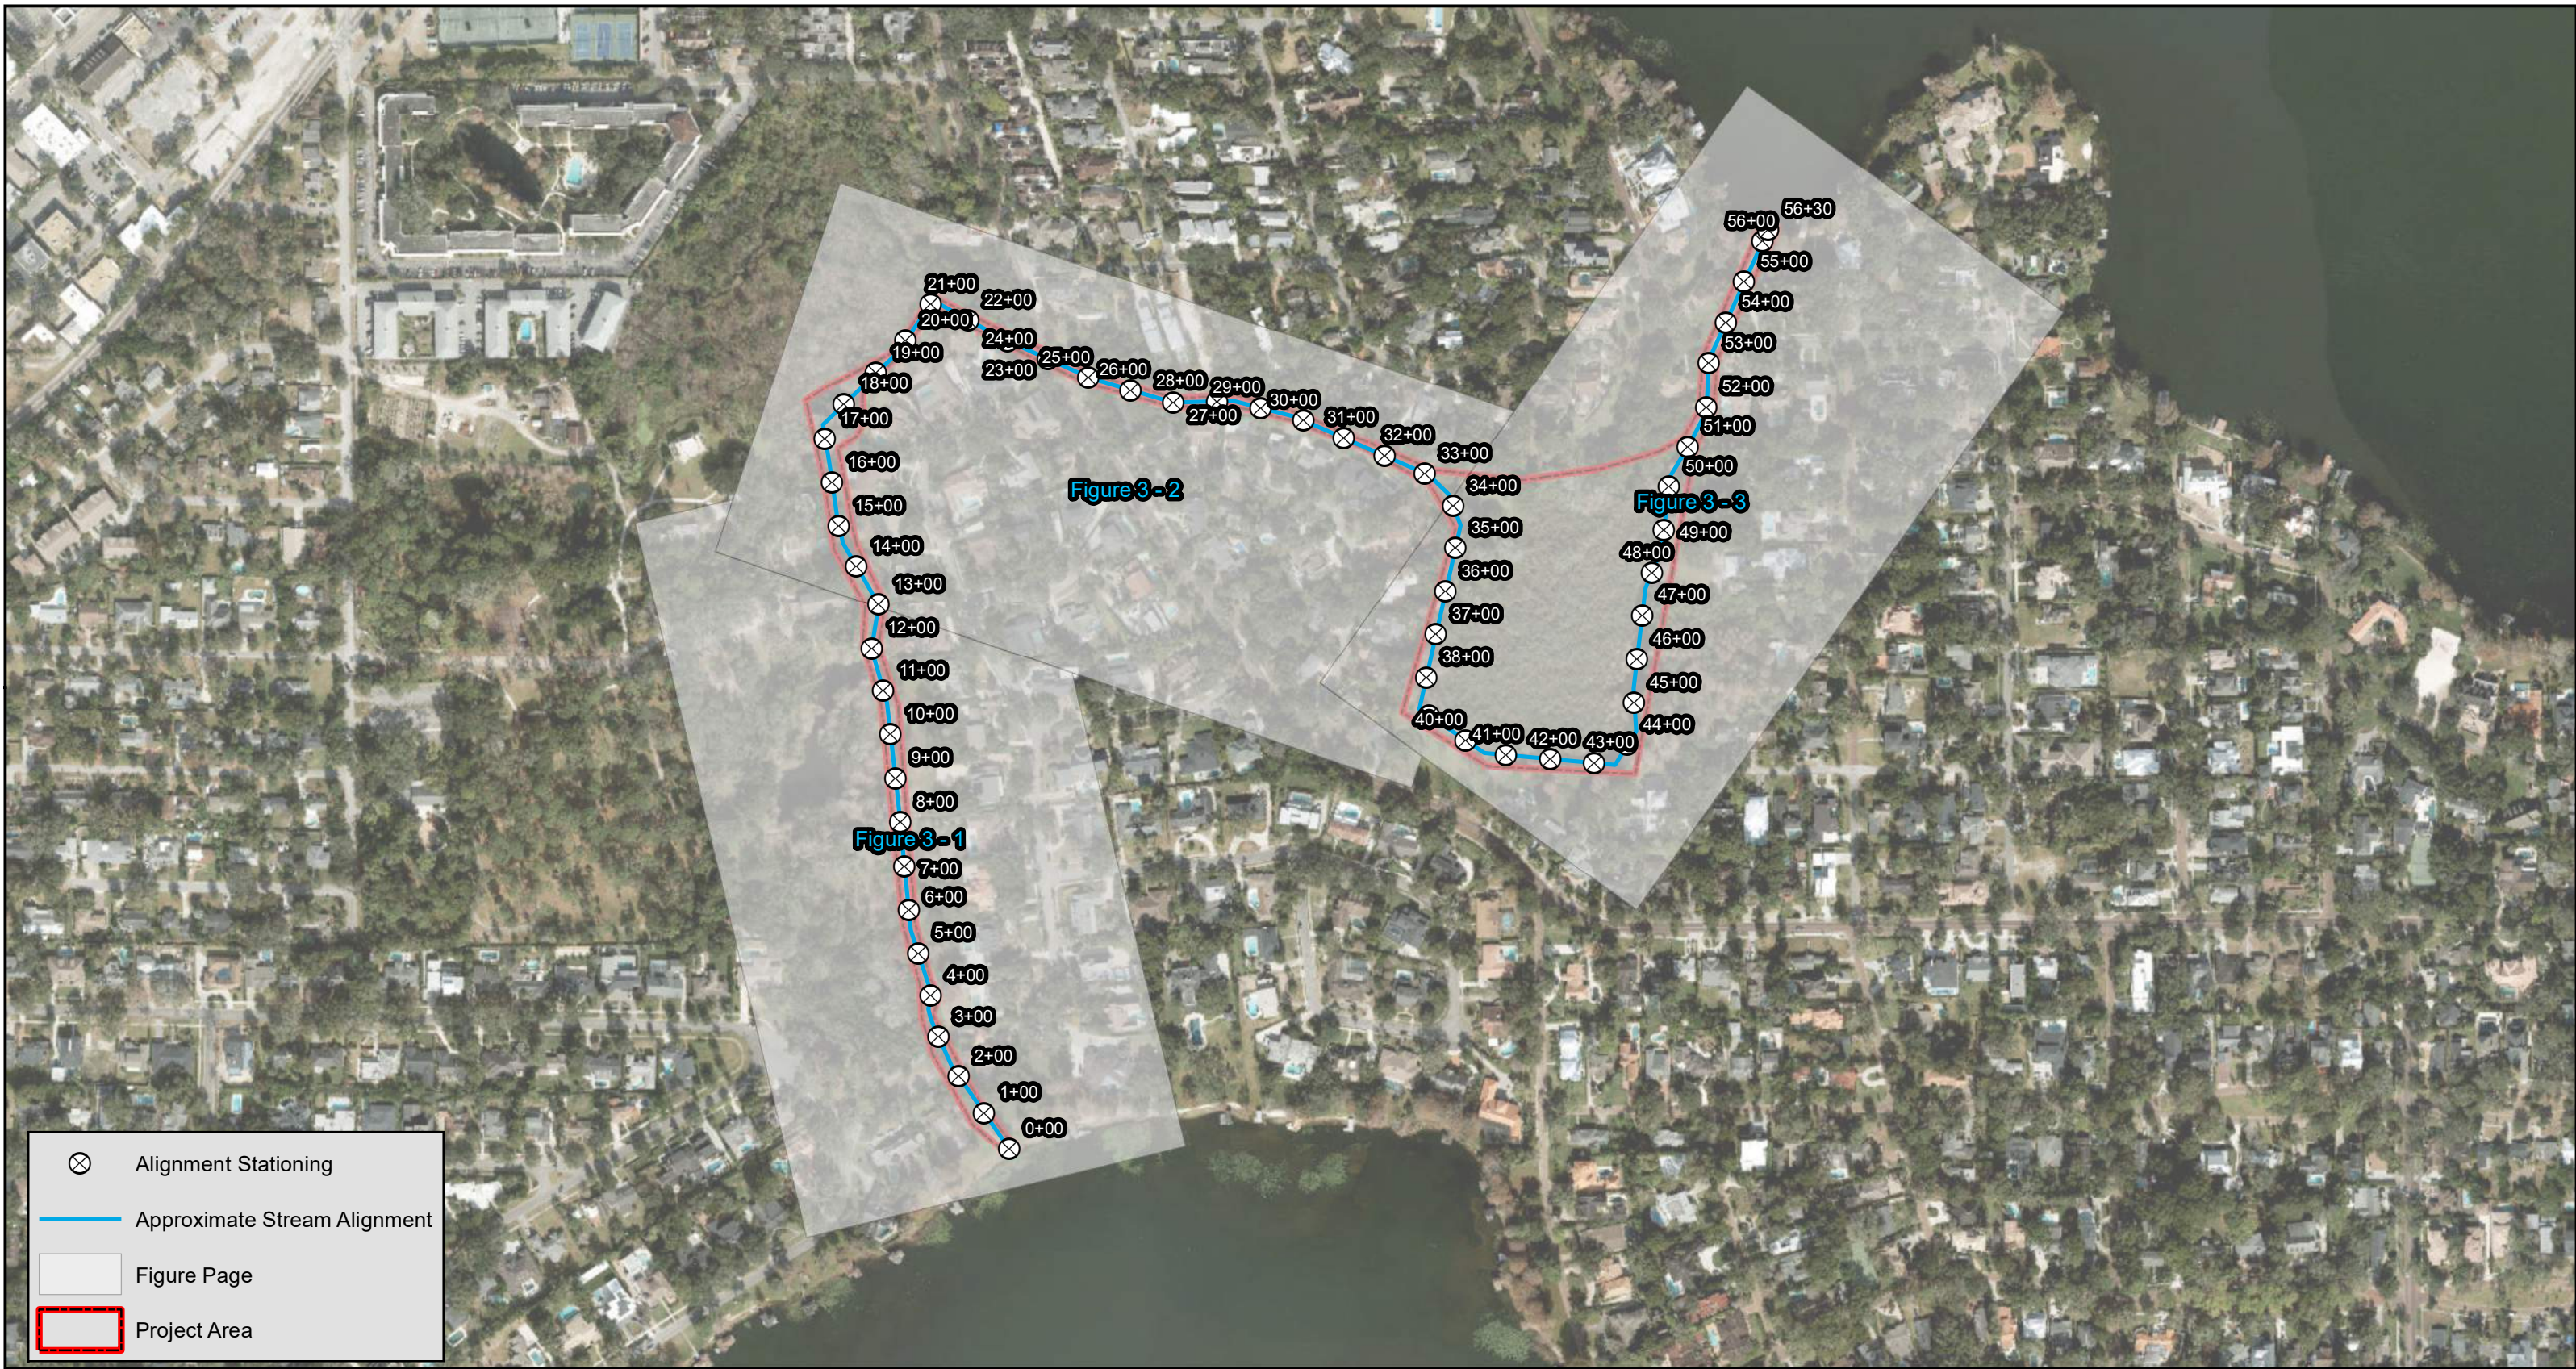
**Figure 3 - Index
Bank Erosion Hazard Map**

From station ~1+00 to station ~1+50, left bank was noted to be actively eroding with a very high BEHI rating and a high NBS rating (**Figures 3 & 4; Attachment A**). Reduced vegetation along this portion of left bank combined

with the increasingly confined nature of Howell Creek moving downstream has contributed to accelerated forces and increased erosion/instability. The remaining portion of the reference reach provided adequate baseline data capturing a stable reach with appropriate pattern, profile, and flood prone streambank access during elevated flow conditions. Overall, the identified reference reach is characterized by a range of bank conditions that were noted throughout Howell Creek and exhibited a healthy baseline for reference design considerations.

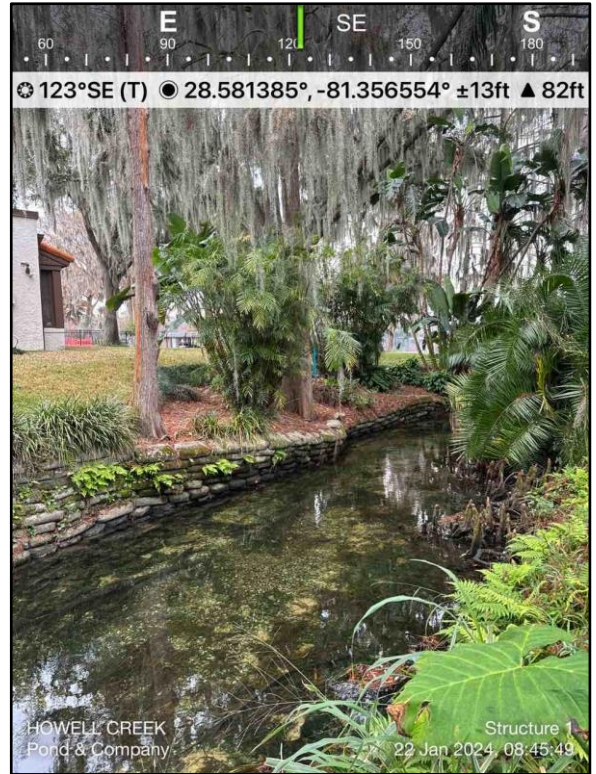
Photograph 2: Structure 1; Concrete Bag Retaining Wall (Priority 0)

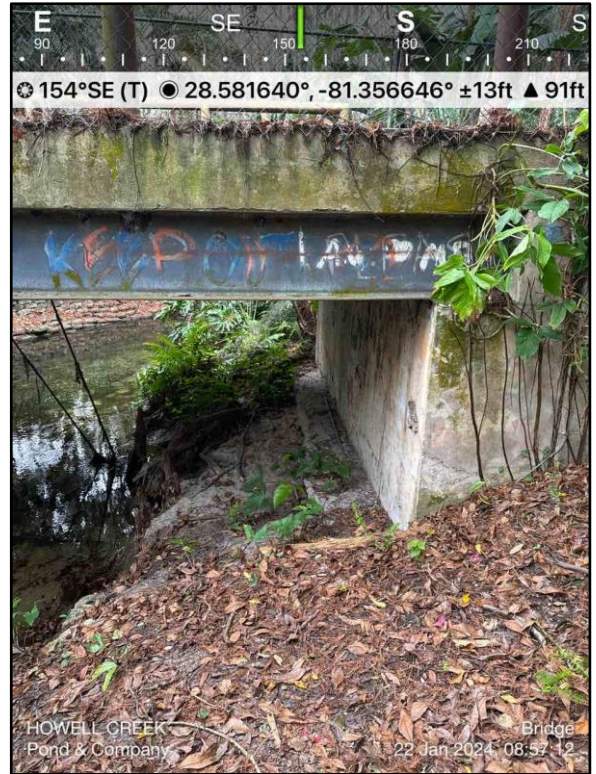
Photograph 6: Bridge Crossing of Upstream Reach of Howell Creek

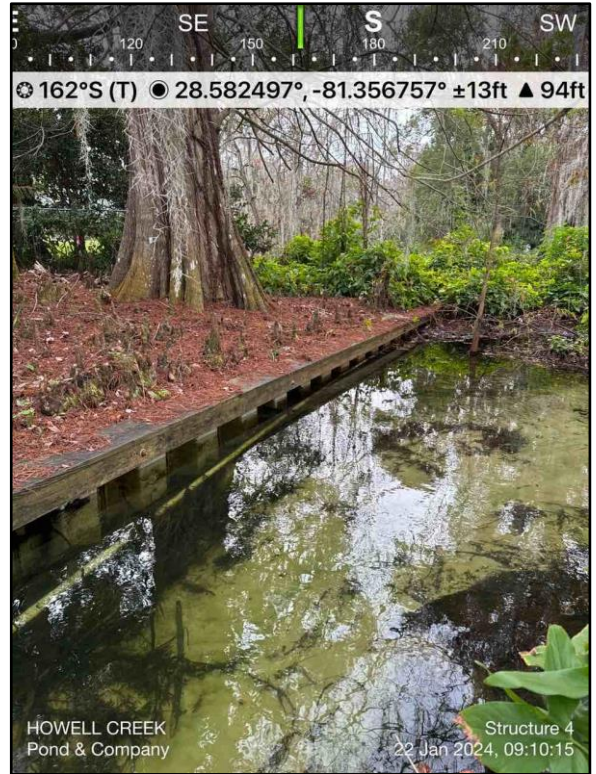
Photograph 10: Structure 4; Sheet Pile Wooden Capped Retaining Wall (Priority 3)

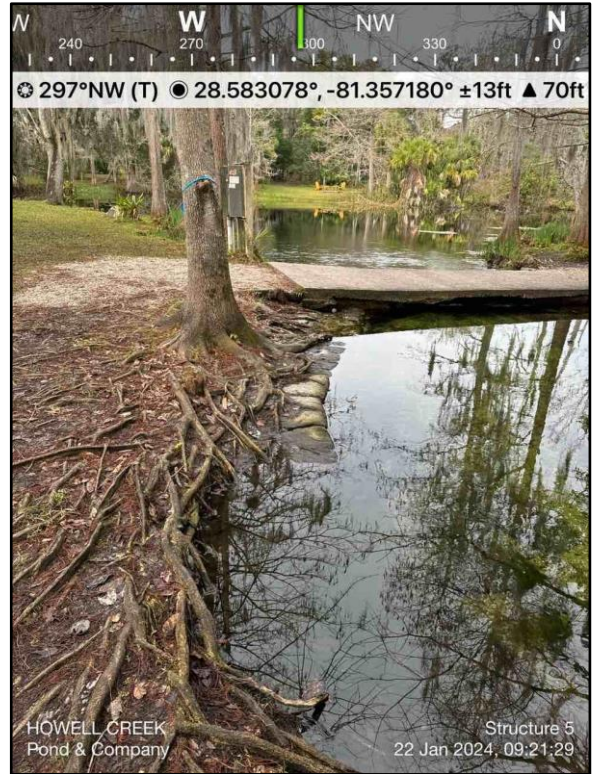
Photograph 14: Structure 5; Subgrade Concrete Bag Retaining Wall (Priority 0)

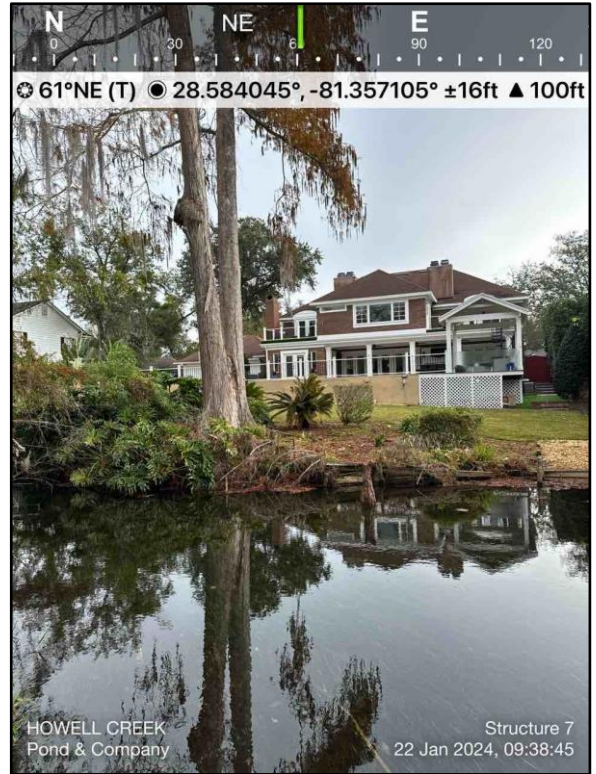
Photograph 18: Structure 7; Wooden Retaining Wall (Priority 2)

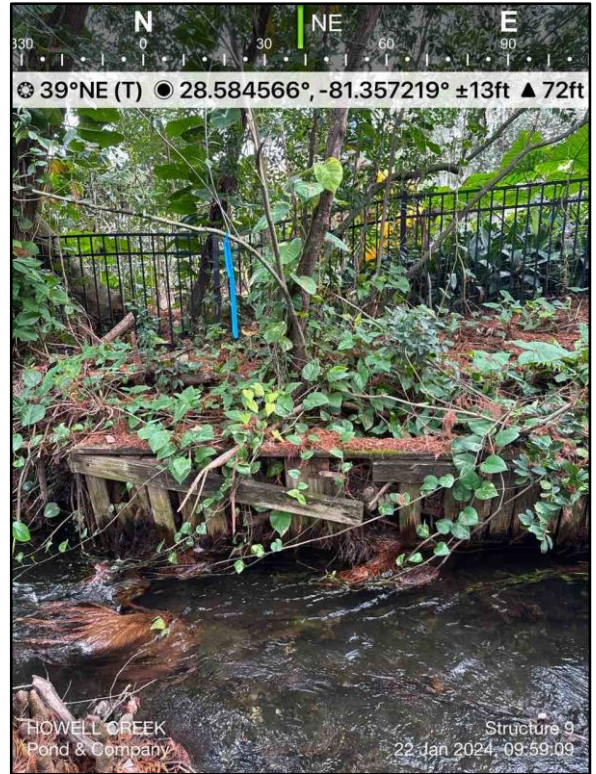
Photograph 22: Structure 9; Wooden Retaining Wall (Priority 5)

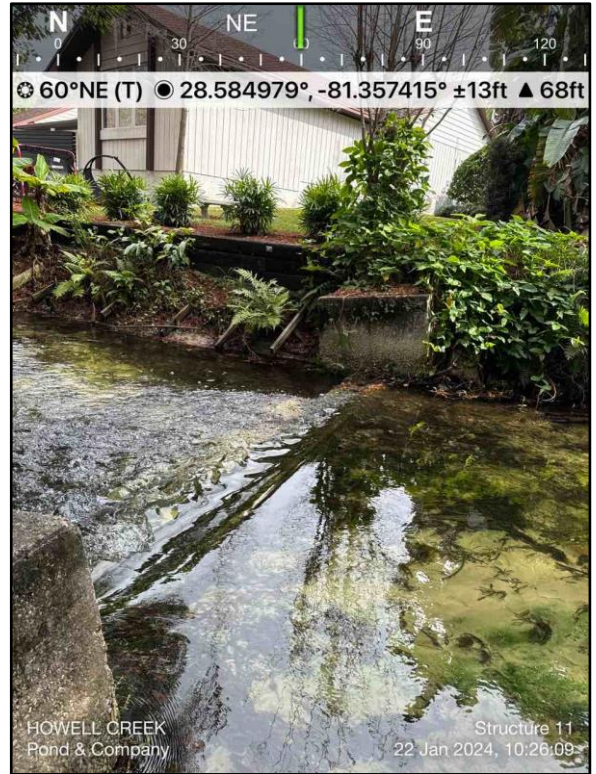
Photograph 26: Structure 11; Grade Control Weir and Adjacent Wooden Retaining Wall (Priority 4)

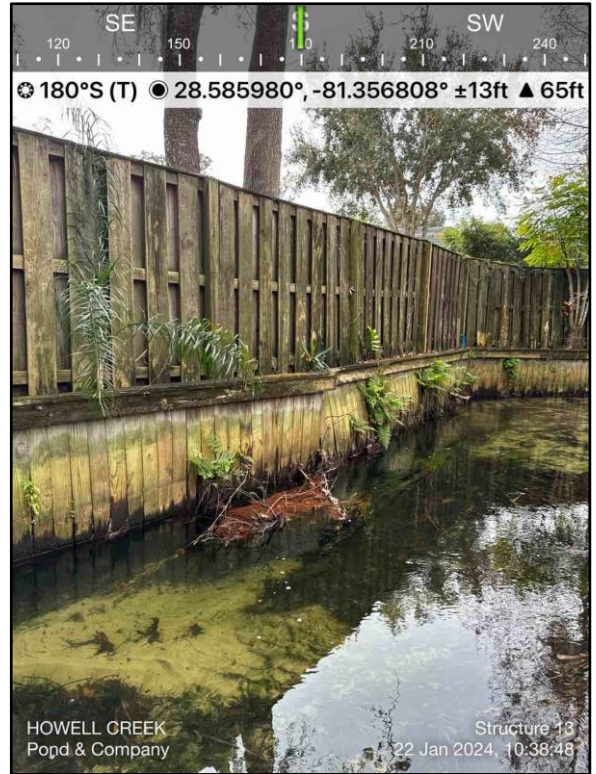
Photograph 30: Structure 13; Wooden Retaining Wall (Priority 3)

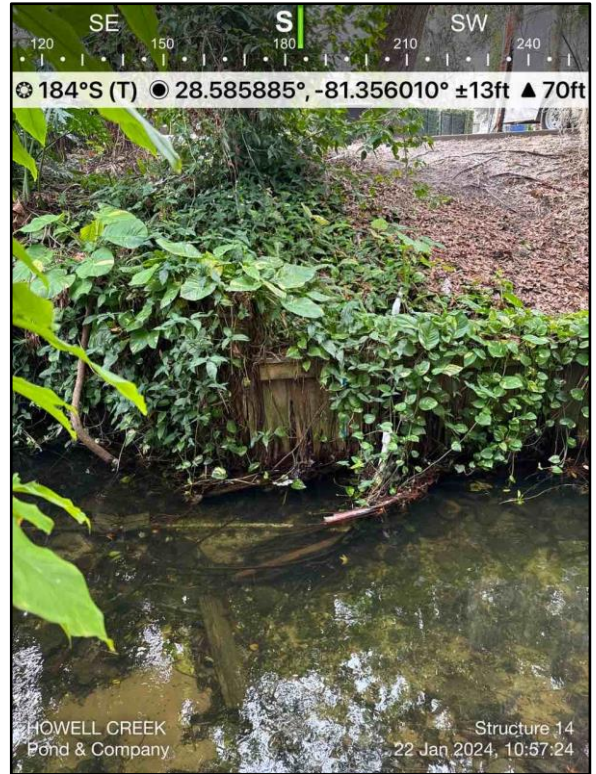
Photograph 34: Structure 14; Wooden/Concrete Bag Retaining Wall at S Penn. Ave. (Priority 4)

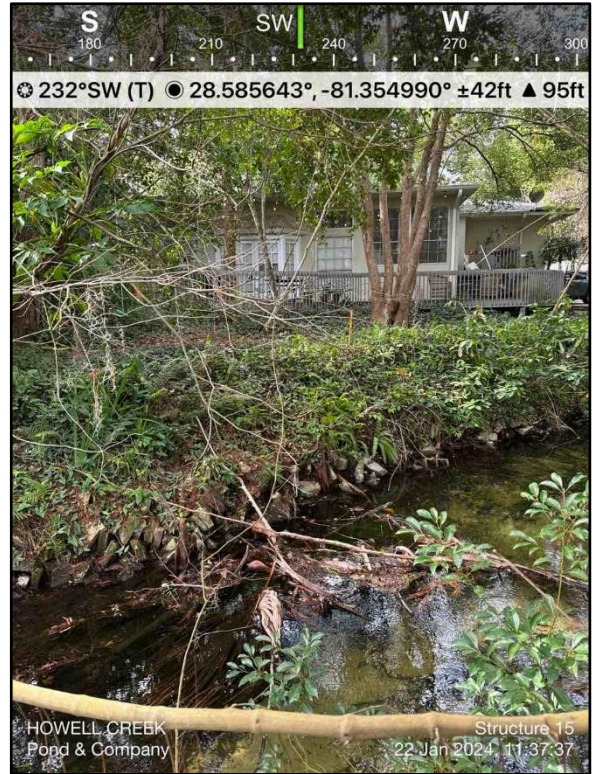
Photograph 38: Structure 15; Rock Streambank Protection (Priority 1)

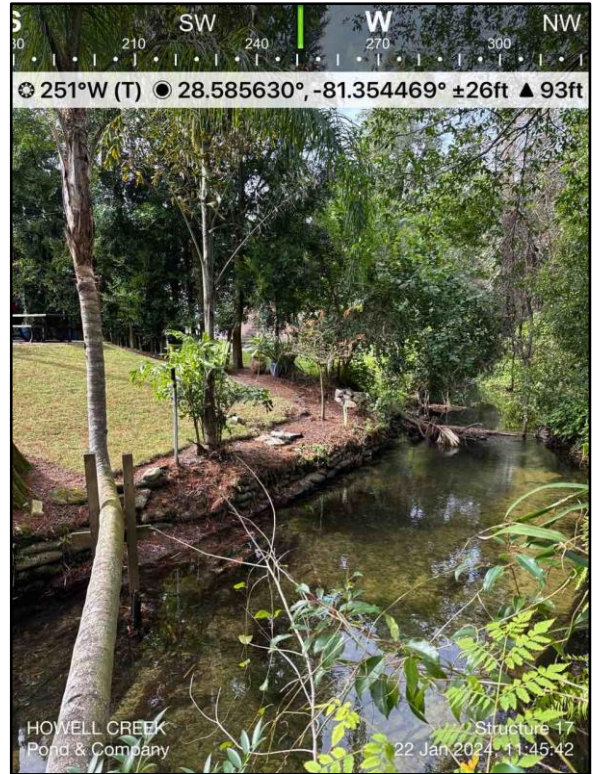
Photograph 42: Structure 17; Concrete Bag Retaining Wall (Priority 0)

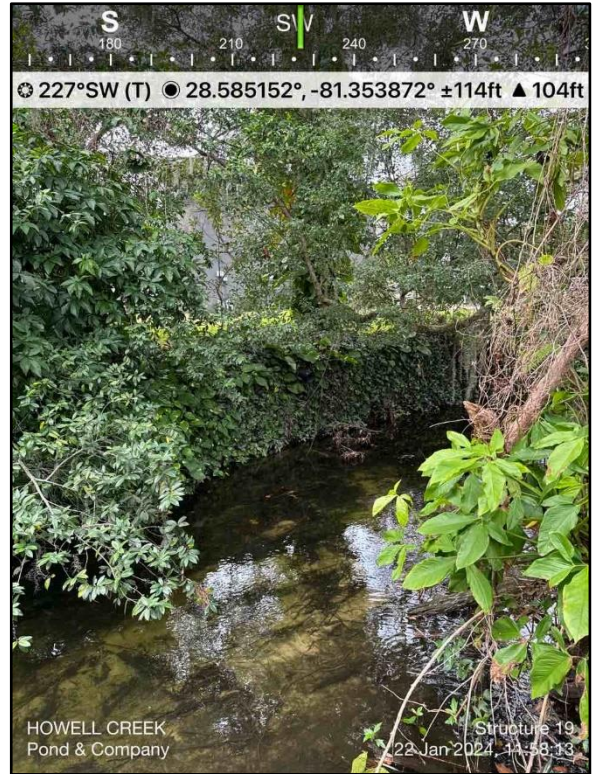
Photograph 46: Structure 19; Concrete Bag Wall and Rock Streambank Protection (Priority 2)

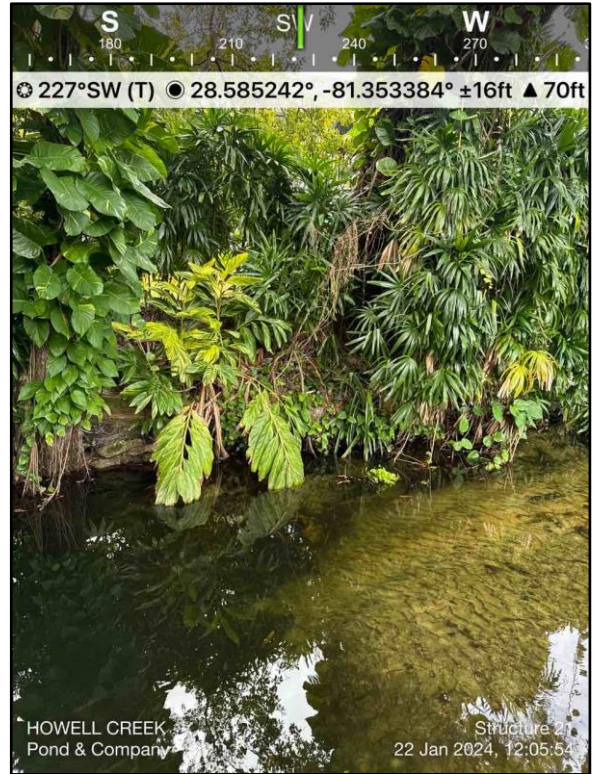
Photograph 50: Structure 21; Concrete Bag Retaining Wall (Priority 0)

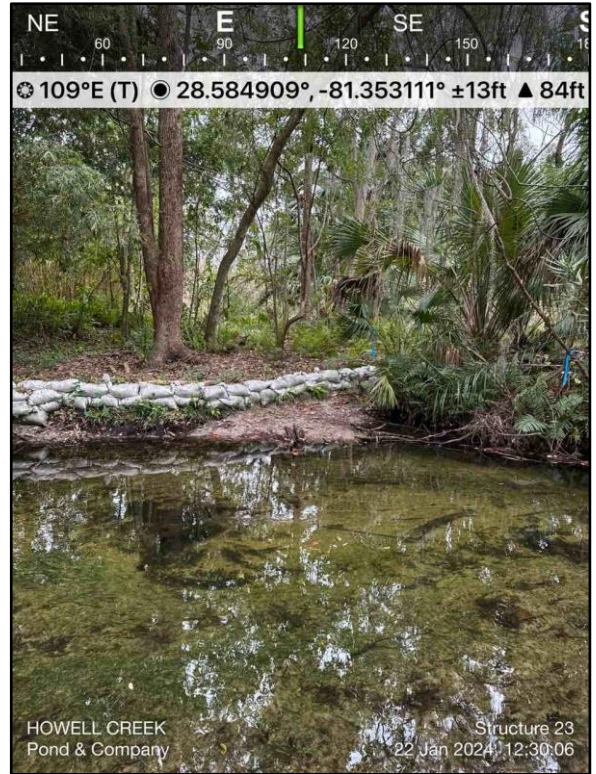
Photograph 54: Structure 23; Sandbag Streambank Protection (Priority 3)

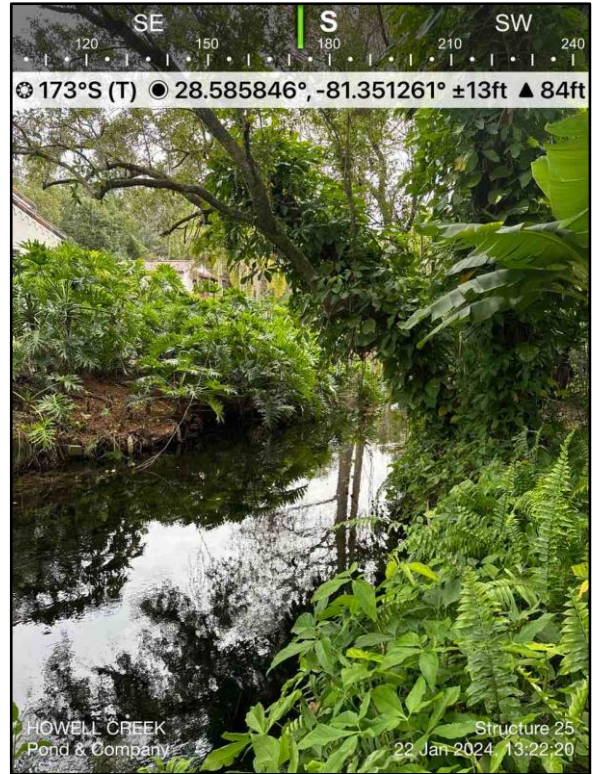
Photograph 58: Structure 25; Concrete and Wooden Retaining Wall (Priority 0)

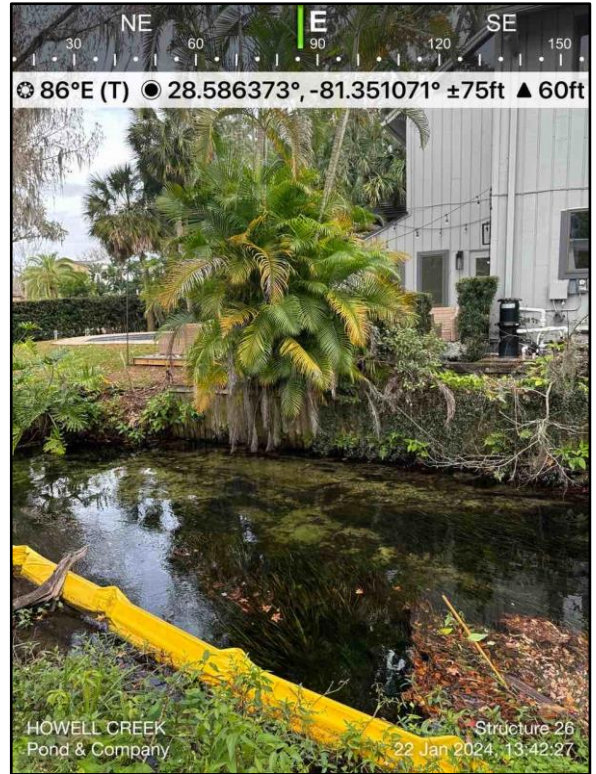
Photograph 62: Structure 26; Wooden Retaining Wall (Priority 4)

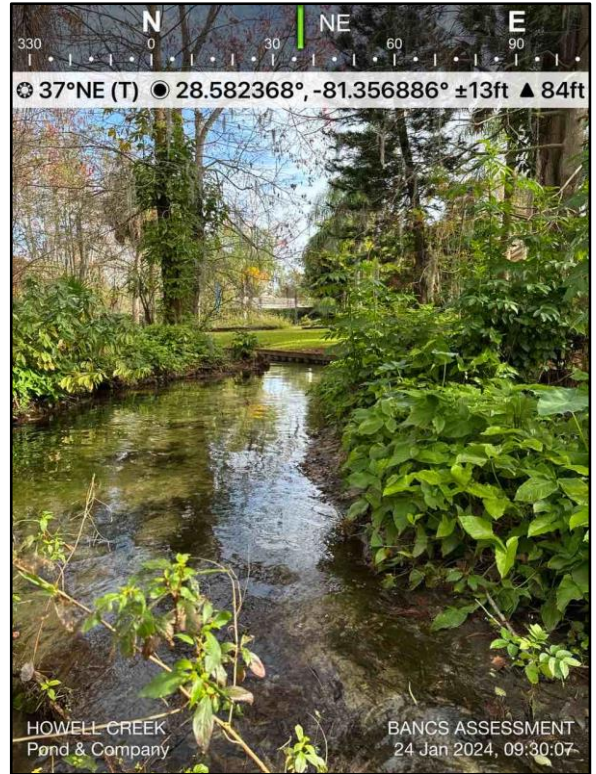
Photograph 66: BEHI = Low, NBS = Moderate (L), Low (R); ~Sta. 5+50.
