# Winter Park Wellness Place

ASHRAE Level II Energy Audit

ASHRAE Level II Audit of the Winter Park Wellness Place.  
600 N Virginia Ave, Winter Park, FL 32789

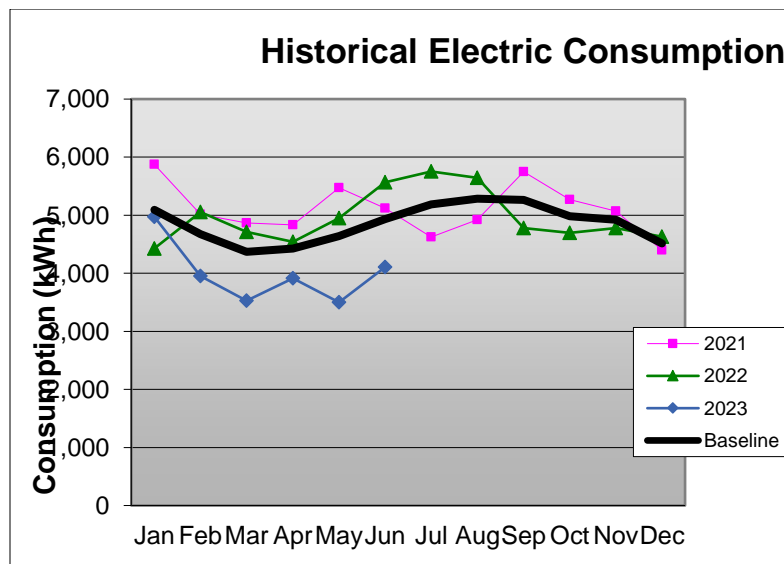
Figure 2: Wellness Place Electric Consumption

The building is currently provided with electricity and water utilities. Electrical utility consumption and demand values were provided for the months of January 2021 through June 2023. The monthly baseline is mostly flat, with some usage increasing at the beginning and end of the warmer months due to cooling needs, and in January from increased electrical heating needs. No billing statements were provided, but a blended rate for kWh savings was determined based on published rates. Calculation of the blended utility rate takes into account the non-fixed costs associated with electrical utilities use by the facility, including fuel charges, per-kWh cost, demand charges, etc. Table 3 details the components of the blended rate calculation.

The following graph and table show the total consumption and demand per monthly billing period for electricity.

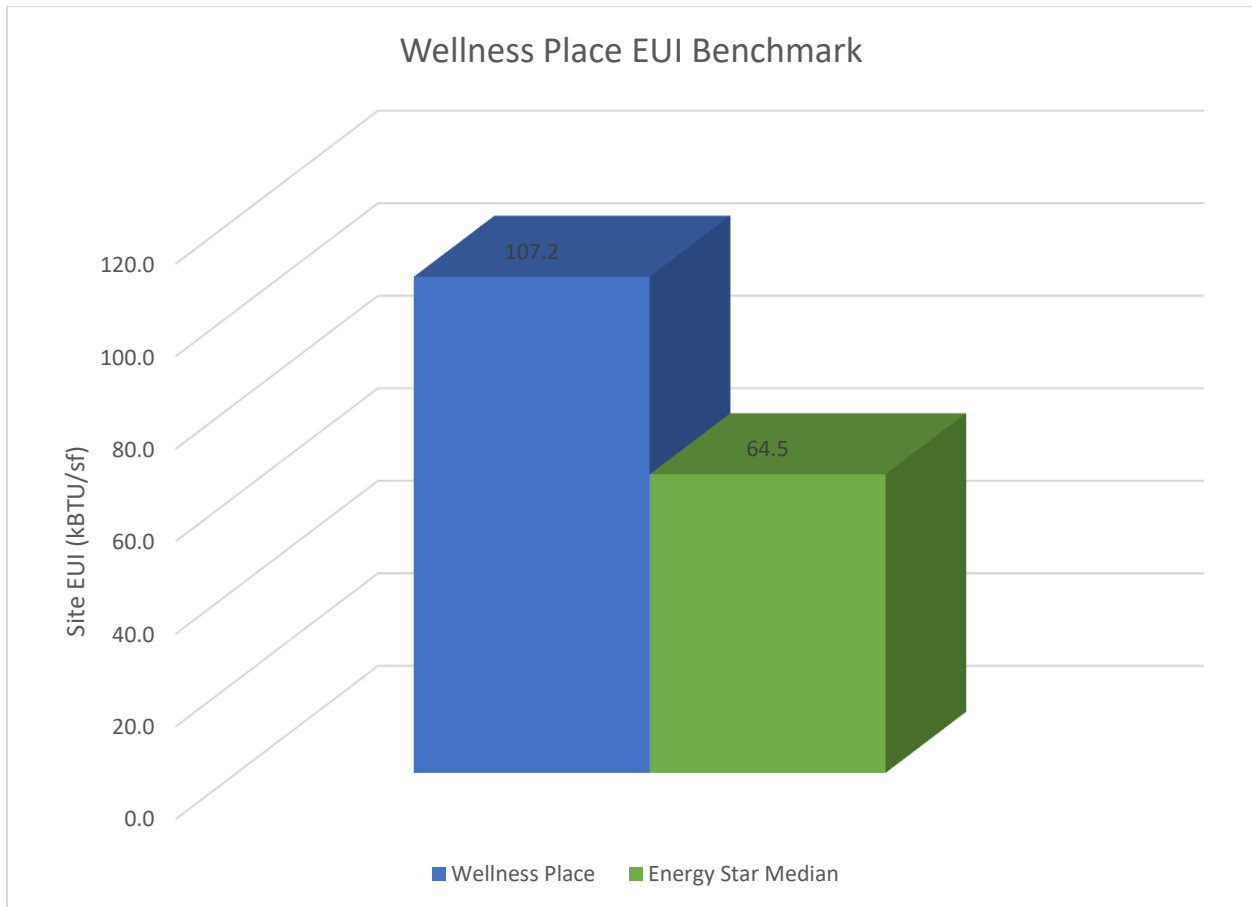
Figure 3: Wellness Place Energy Performance Comparison

Based on most recent 24 months of utility data, a comparison can be drawn between Wellness Place and the average energy use intensity (EUI) of similar buildings throughout the United States. The median EUI for an outpatient clinic building in the United States is 64.5 kBTU/sf, and the calculated EUI of Wellness Place is 107.2 kBTU/sf. It is worth noting that the median value reported by Energy Star is dependent on the annual responses from building surveys, and that the occupant load and climate conditions of buildings of the same type can vary significantly, as well as the equipment in use within similar clinics. The energy conservation measures detailed in this report will serve to decrease the EUI of the Wellness Place facility through efficiency increases.

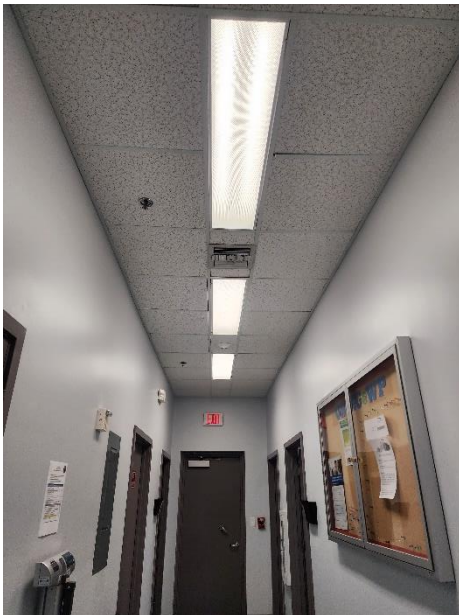
The facility was observed to have predominantly linear fluorescent fixtures with T8 lamps. Existing non-LED lighting will be replaced with new LED lighting on a one-for-one basis. Existing lighting material waste will be disposed of according to local regulations.

C-7: Hallway fluorescent lighting

Existing fluorescent and incandescent lighting fixtures will be replaced/retrofitted with new LED lighting fixtures. This will greatly reduce the energy required to illuminate the building. Additionally, cooling systems will have to run less often to offset the heat generated by the lighting. There are several additional benefits to LED lighting technology. LED lighting has longer burn hour life, faster on/off response time, and easier dimming capabilities compared to fluorescent and incandescent technologies. Because LED light fixtures have longer burn hour life, this will reduce the material and time cost of replacing burned out lamps.

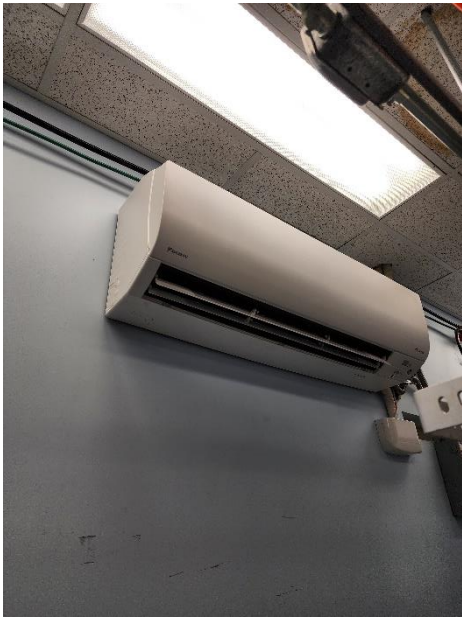
C-9: Fan Coil Unit

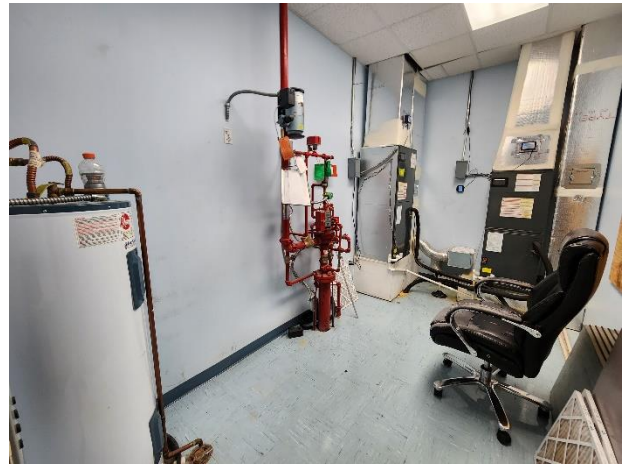
Domestic hot water for the facility is provided by an electric water heater manufactured in 1997. This water heater is at the end of its useful life and a scheduled replacement is recommended to preemptively avoid any unplanned maintenance to the facility.

C-10: Electric Water Heater and Air Handling Units

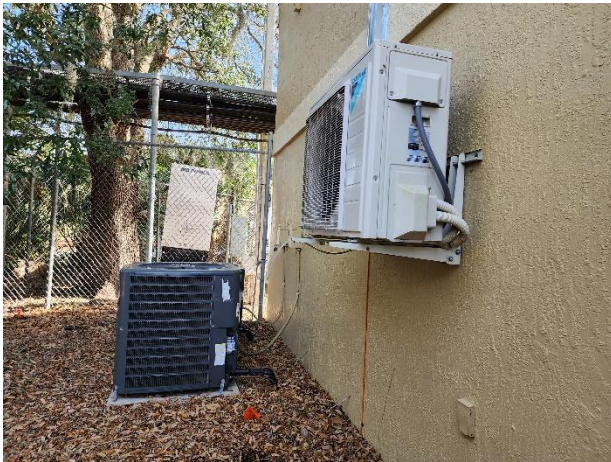
C-11: Mini-split condensing unit

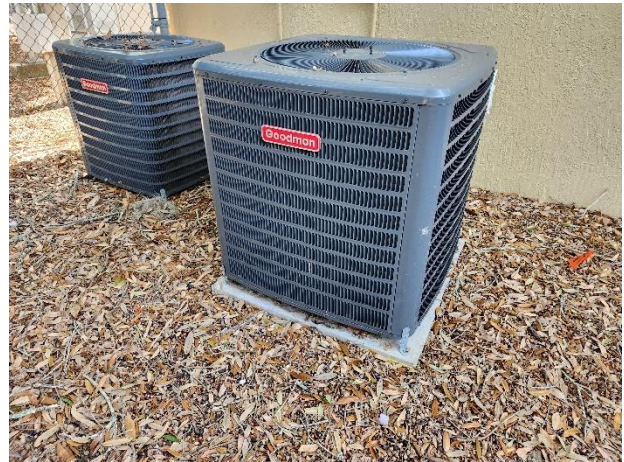
C-12: Condensing units

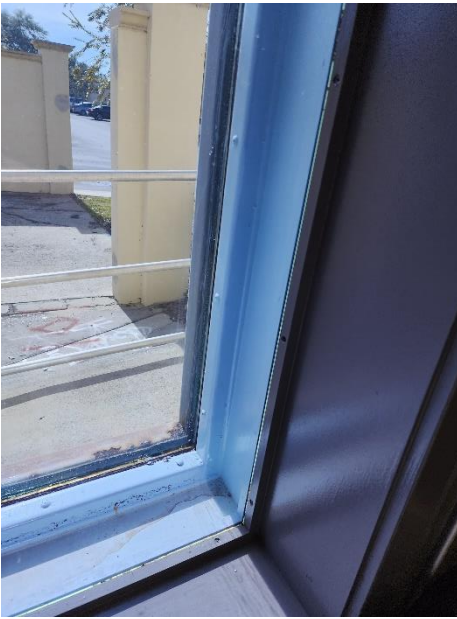
The building envelope consists of a stucco façade over CMU block walls. The roof is a flat, built-up construction with equipment located on the roof. There were no issues noted in relation to the audit scope from the observable elements of the building envelope. However, the audit team noted that there were some windows that showed signs of water intrusion.

C-13: Window frame showing water intrusion
