9/29/2023

Winter Park Farmers' Market & Historical Museum

ASHRAE Level II Energy Audit

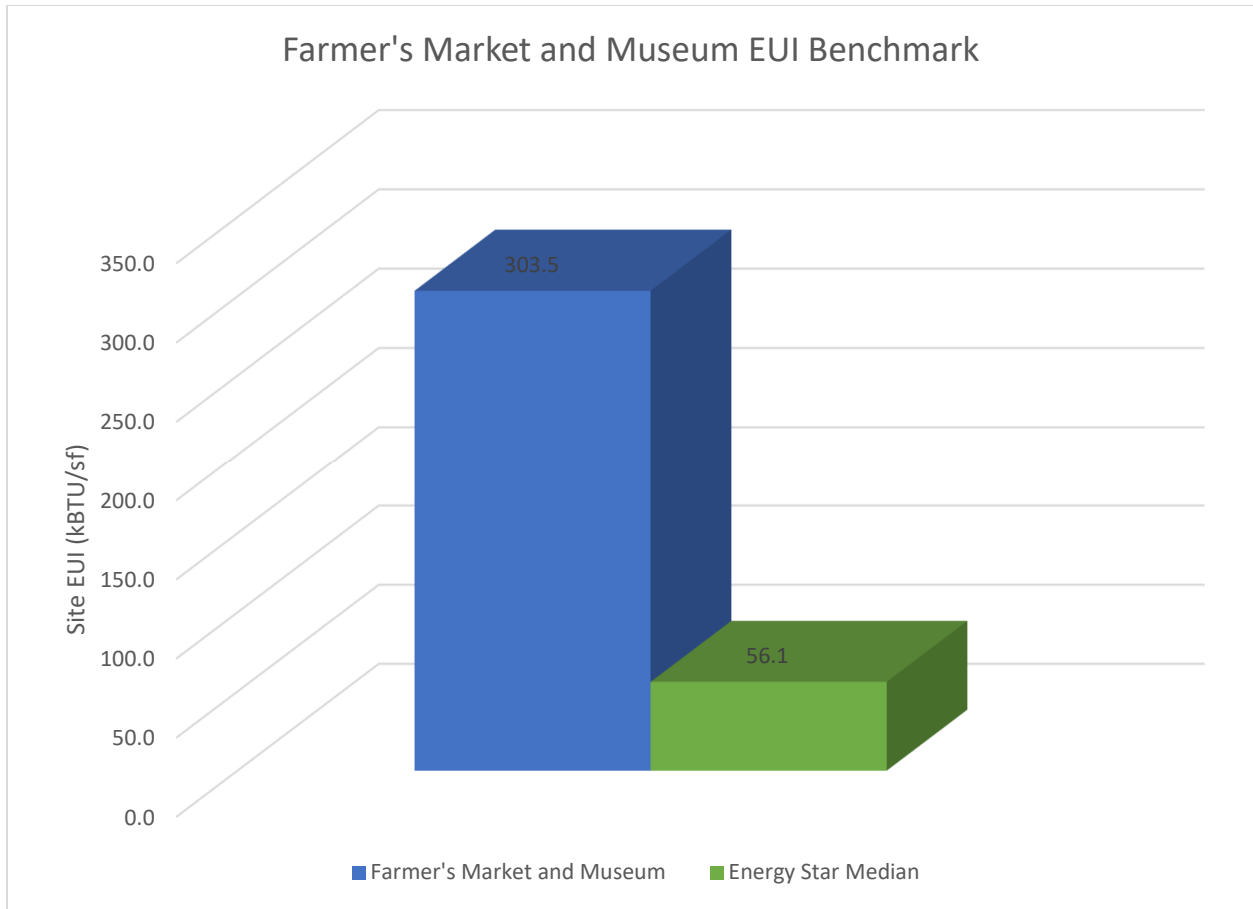
Figure 3: Farmer’s Market Energy Performance Comparison

The building’s calculated site energy use intensity – the amount of electricity consumed onsite per square foot of building area – of the Farmer’s Market of 303.5 kBTU per square foot is approximately 441 percent higher than the baseline Energy Star comparison value of 56.1 kBTU per square foot.

This measure is based upon the feedback of building owners and operators for the previous year, and does not account for every variable in the operation and construction of the building. For example, the historic nature of the Farmer’s Market is likely a significant contributing factor to its higher energy use, as the building’s intended use has changed and construction standards for energy efficiency have become more strict in the subsequent decades. Additionally, air infiltration due to the historic doors to the train platform was specifically noted as a concern relating to the air conditioning and humidity control for the facility. The energy conservation measures detailed later in this report are intended to improve the EUI of the buildings and reduce their overall energy consumption.

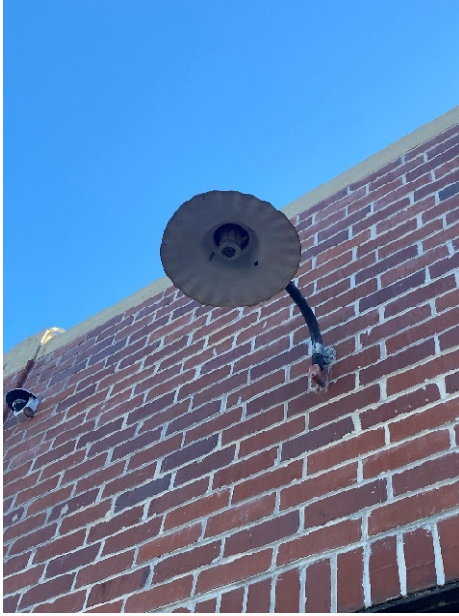
C-1: Exterior Lighting Fixture

Exterior lights for the facility are currently being operated through a timer. Occasionally, the facilities maintenance staff has had to adjust the timer with regard to changing daylight hours throughout the year. To cut down on maintenance efforts, it is recommended to replace the timer control with a simple photo cell controller to synchronize exterior lighting hours in conjunction with daylight hours from day to day.

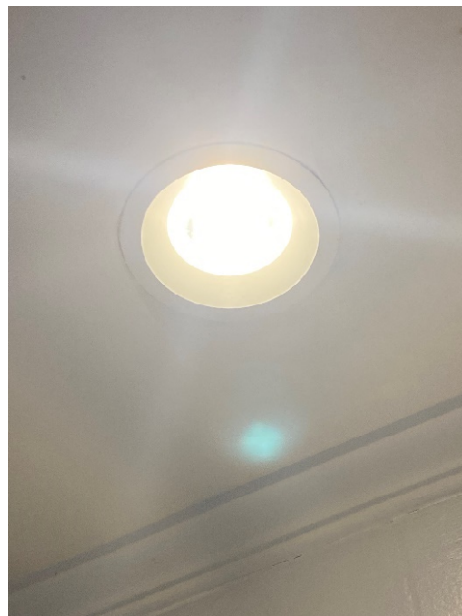
C-4: Kitchen Lighting Fixture

The facility was observed to have predominantly incandescent fixtures. Existing non-LED lighting will be replaced with new LED lighting on a one-for-one basis. Existing lighting material waste will be disposed of according to local regulations.

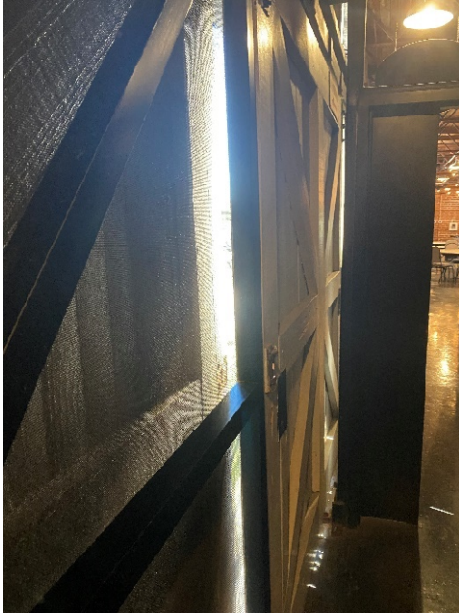
The Winter Park Farmers Market & Museum has 10 barn door panels along the west side of the building that each have a 1" gap around the perimeter of the panels that outside air can infiltrate through. Sealing these gaps will reduce load on the HVAC systems of conditioning the infiltrated outside air. Instead of reducing infiltration on existing doors, the City has received a price to replace the existing doors with new sliding doors intended to better seal the building envelope while maintaining the historic integrity of its appearance. Pricing for these doors has been reflected in the payback calculation above (\$10,000 per door).

C-9: Historic Train Depot Door

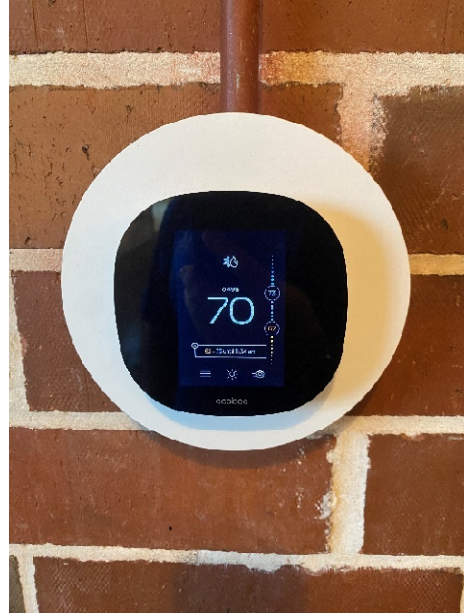
The building is not currently controlled by a centralized Building Automation System (BAS). All mechanical, electrical, and plumbing systems operate in a standalone fashion. However, the rooftop units have been outfitted with Ecobee smart thermostats. The Ecobee system allows for some monitoring, as well as remote scheduling and setpoint adjustment of the different HVAC systems. It was observed during the onsite audits that exhaust fans are manually set to run at all times.

C-10: Ecobee Smart Thermostat

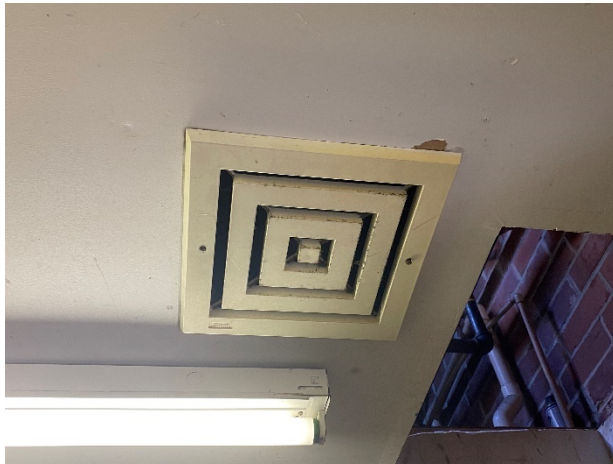
Exhaust fans were observed on the rooftop, providing general exhaust for restrooms located within the building.

C-11: Exhaust Fan Grille

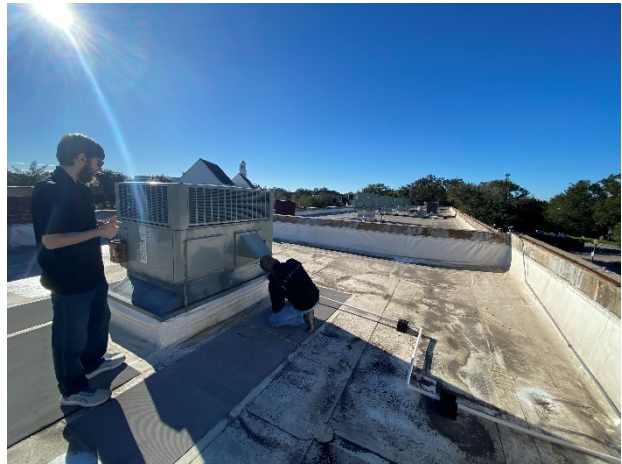
Air conditioning for the majority of the building is provided by seven (7) packaged rooftop air handling units. The units consist mainly of a two-position ventilation damper, supply fan, and DX cooling coil to provide conditioning to the facility. All air handling units are located on the roof of the building, with most serving the open events space to provide cooling and dehumidification. However, facility staff experience humidity issues in the spaces regularly due to unconditioned outside air entering the facility during events. The drawings provided to TLC depict the majority of the current rooftop air handling units; however, it appears that not all units’ information is captured in the drawings that were available.

C-12: Rooftop Unit (Photo 1)

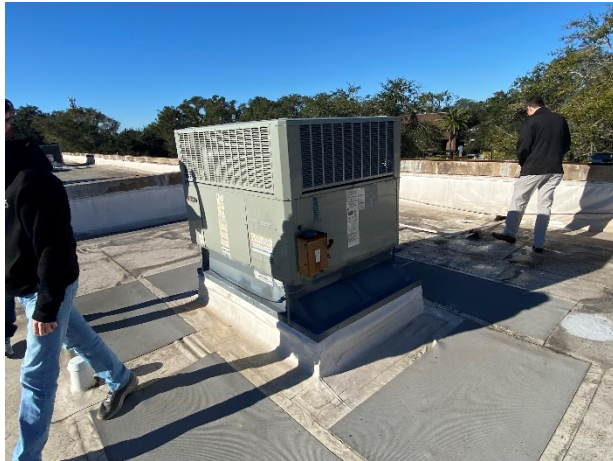
C-13: Rooftop Unit (Photo 2)

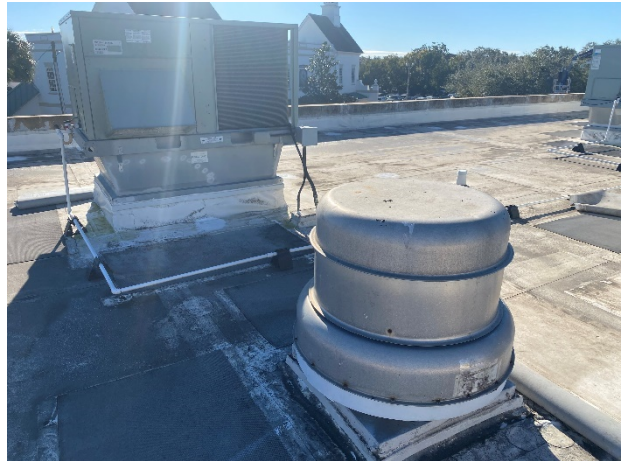
C-14: Rooftop Exhaust Fan

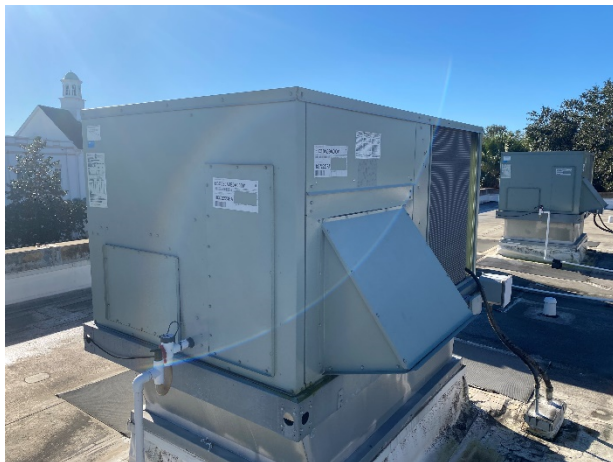
C-15: Rooftop Unit (Photo 3)
