March 26, 2024

**SUBJECT: *Existing Conditions Stream & Streambank Structure Assessment*
Howell Creek Streambank Stabilization/Restoration
City of Winter Park, Orange County, Florida**

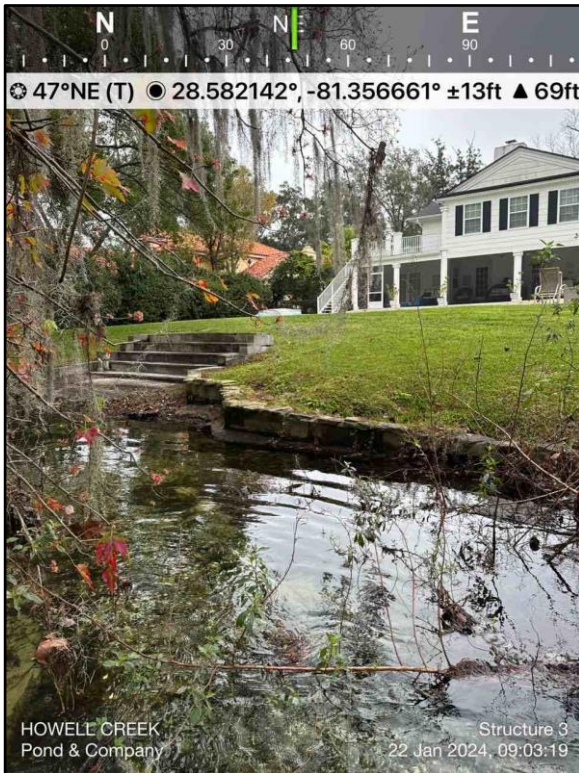
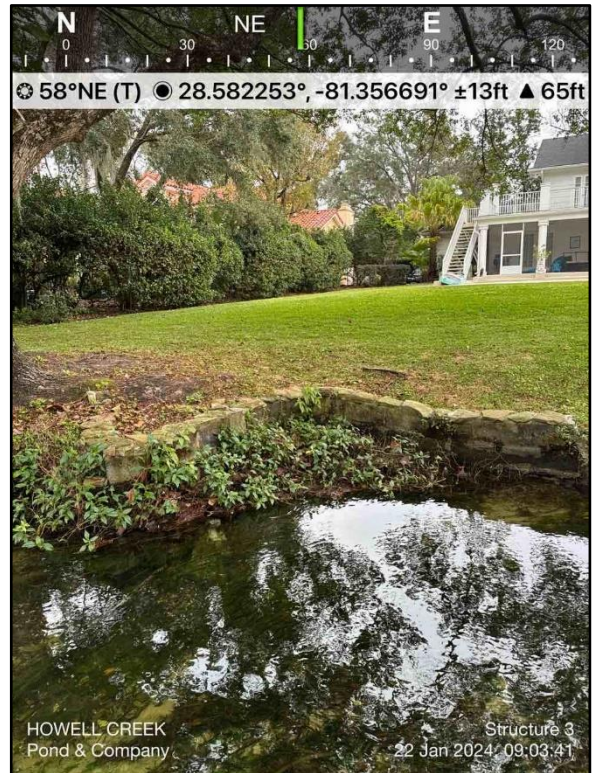
Photograph 7: Structure 3; Block and Mortar Retaining Wall (Priority 2)

Photograph 8: Structure 3; Block and Mortar Retaining Wall (Priority 2)

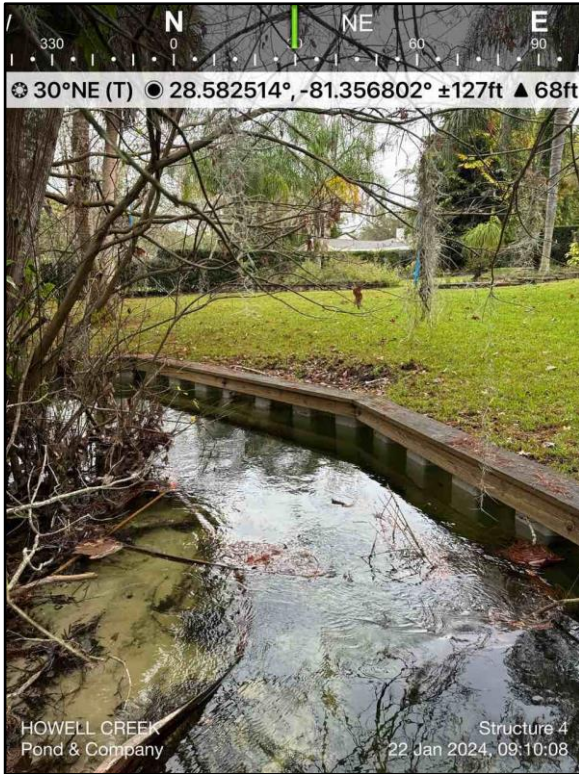
Photograph 9: Structure 4; Sheet Pile Wooden Capped Retaining Wall (Priority 3)

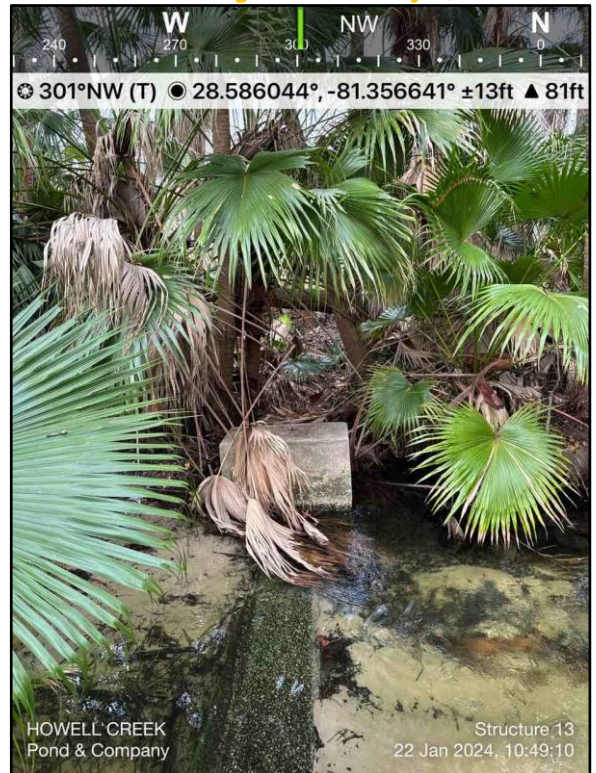
Photograph 31: Grade Control Wier downstream of Structure 13 (Priority 4)

Photograph 32: Grade Control Wier downstream of Structure 13 (Priority 4)

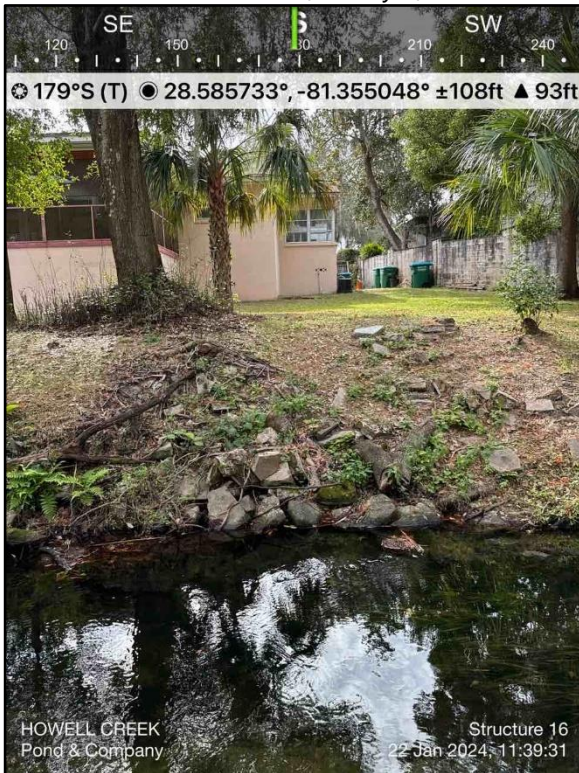
Photograph 39: Structure 16; Rock Streambank Protection & Concrete Bag Wall (Priority 0)

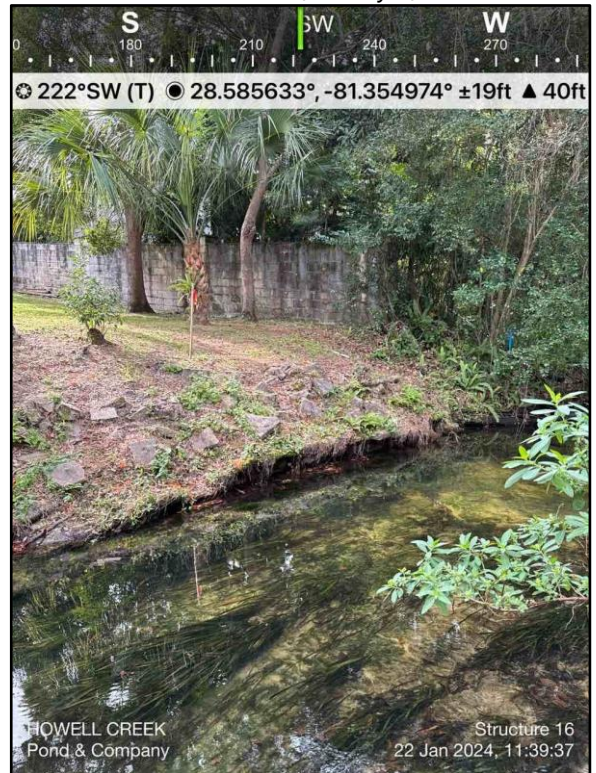
Photograph 40: Structure 16; Rock Streambank Protection & Concrete Bag Wall (Priority 0)

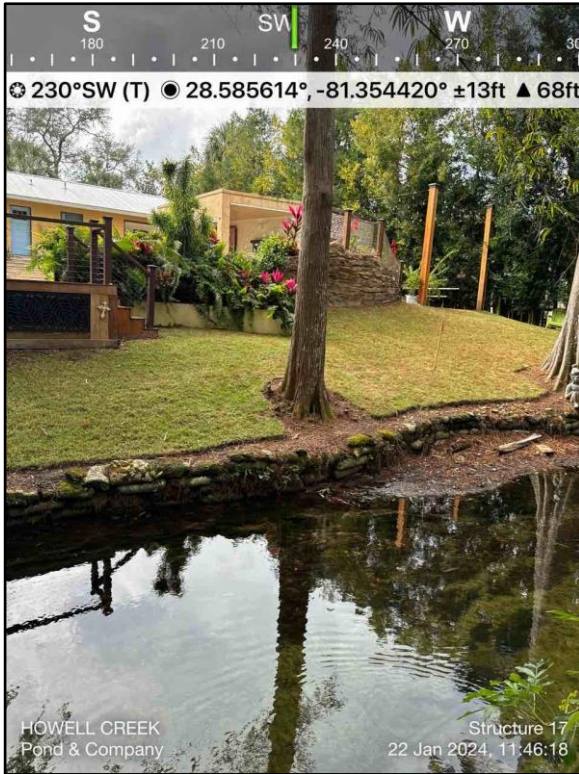
Photograph 41: Structure 17; Concrete Bag Retaining Wall (Priority 0)

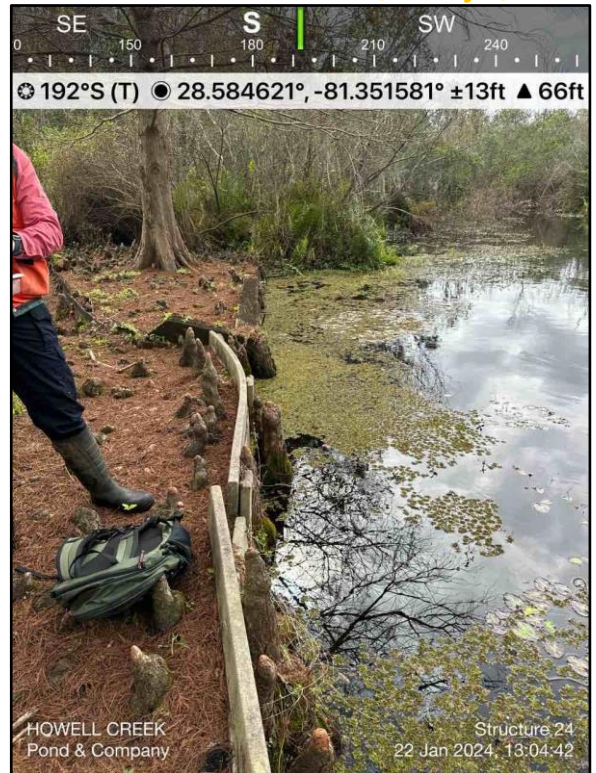
Photograph 56: Structure 24; Wooden/Composite Retaining Wall (Priority 2)

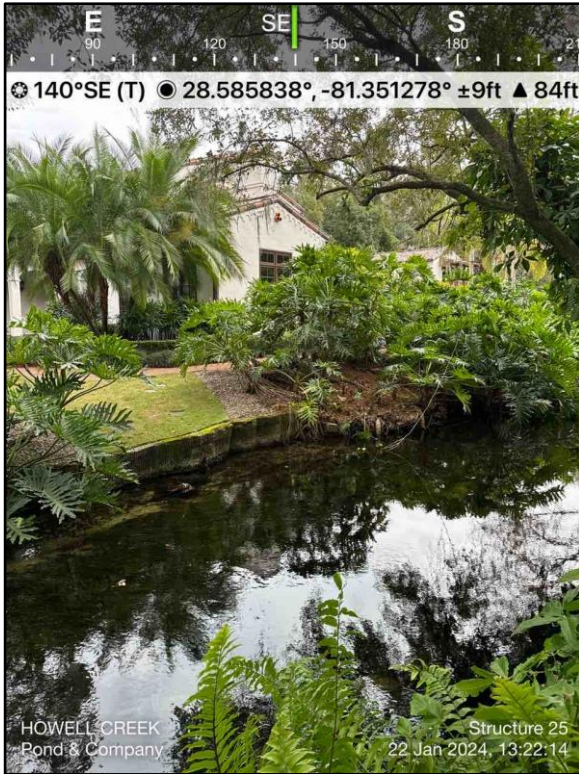
Photograph 57: Structure 25; Concrete and Wooden Retaining Wall (Priority 0)

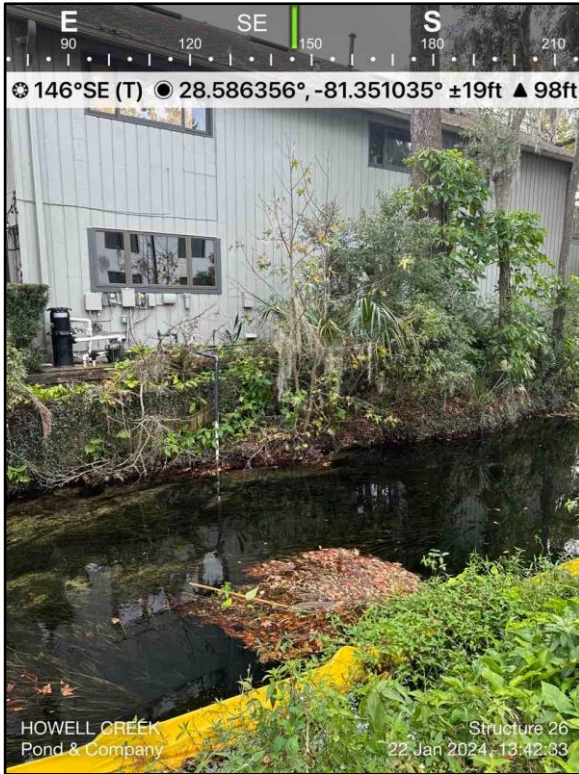
Photograph 61: Structure 26; Wooden Retaining Wall (Priority 4)

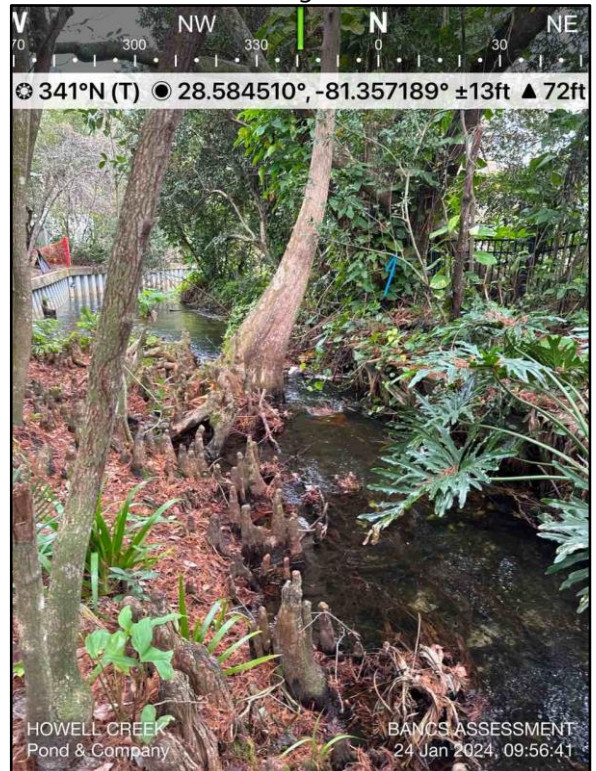
Photograph 72: BEHI = Moderate,
NBS = Moderate; ~Sta. 13+50.
