LAKE MIDGET

Lake Midget water clarity 1998 through 2015 (in meters)

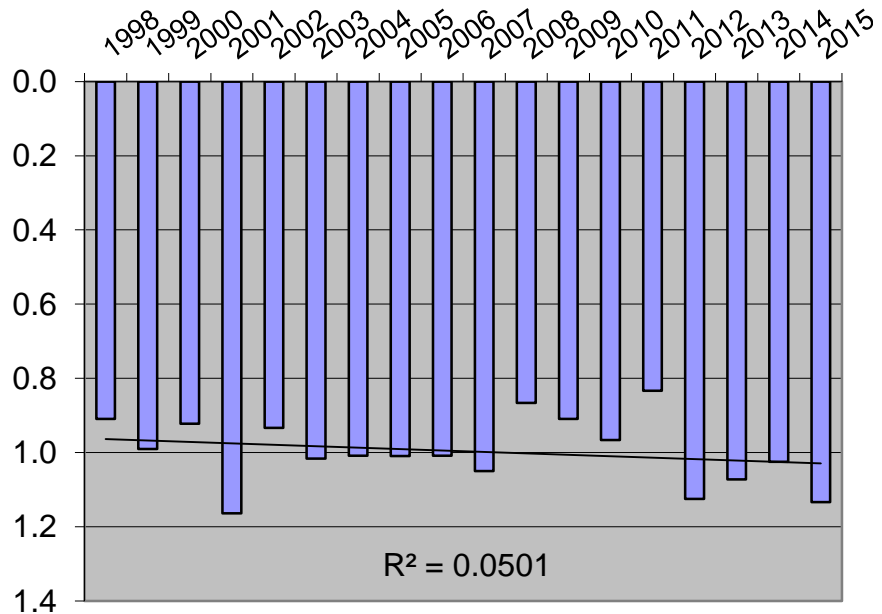
Water Quality: Water quality in Lake Midget is primarily affected by stormwater runoff. Annual average Secchi disk transparency data from 1998 through 2015 show no statistical changes in water clarity over the period of record.
