# CRA STORMWATER MASTER PLAN UPDATE AND EXPANSION REPORT

Geosyntec Consultants, Inc.  
3504 Lake Lynda Drive, Suite 155  
Orlando, Florida 32817

December 2024

# CRA Study Update and Lake Killarney Expansion

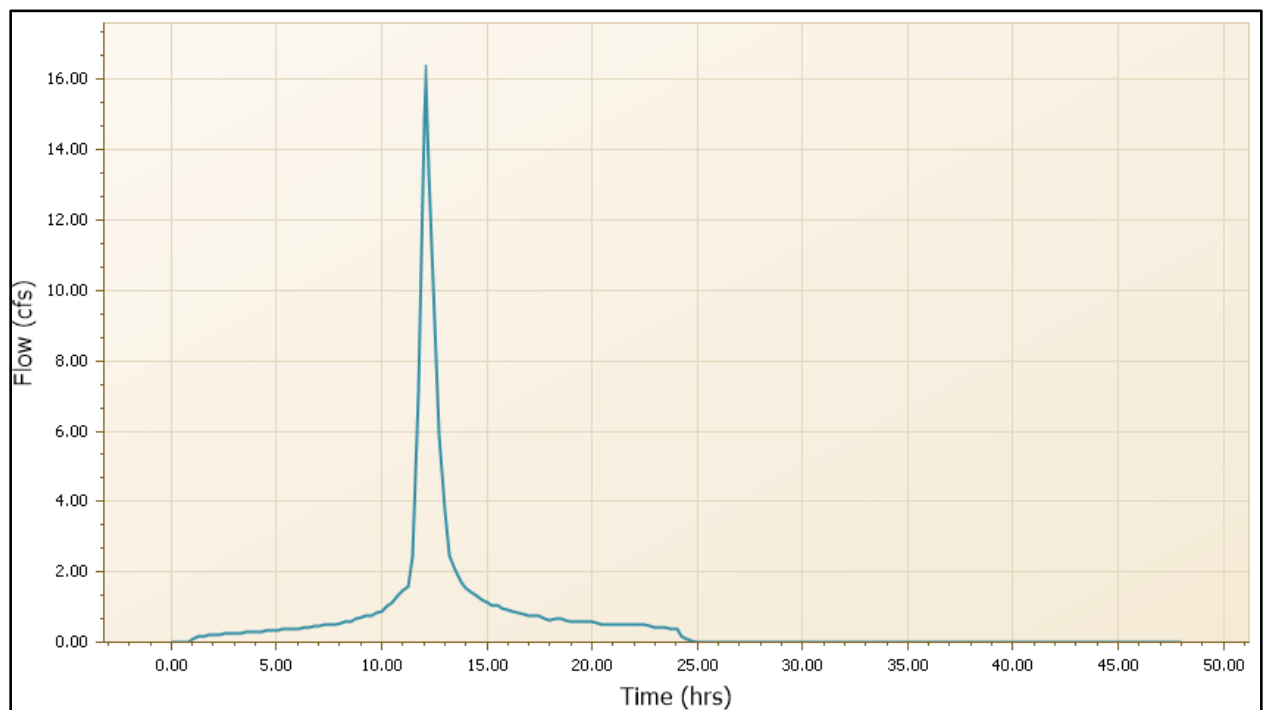
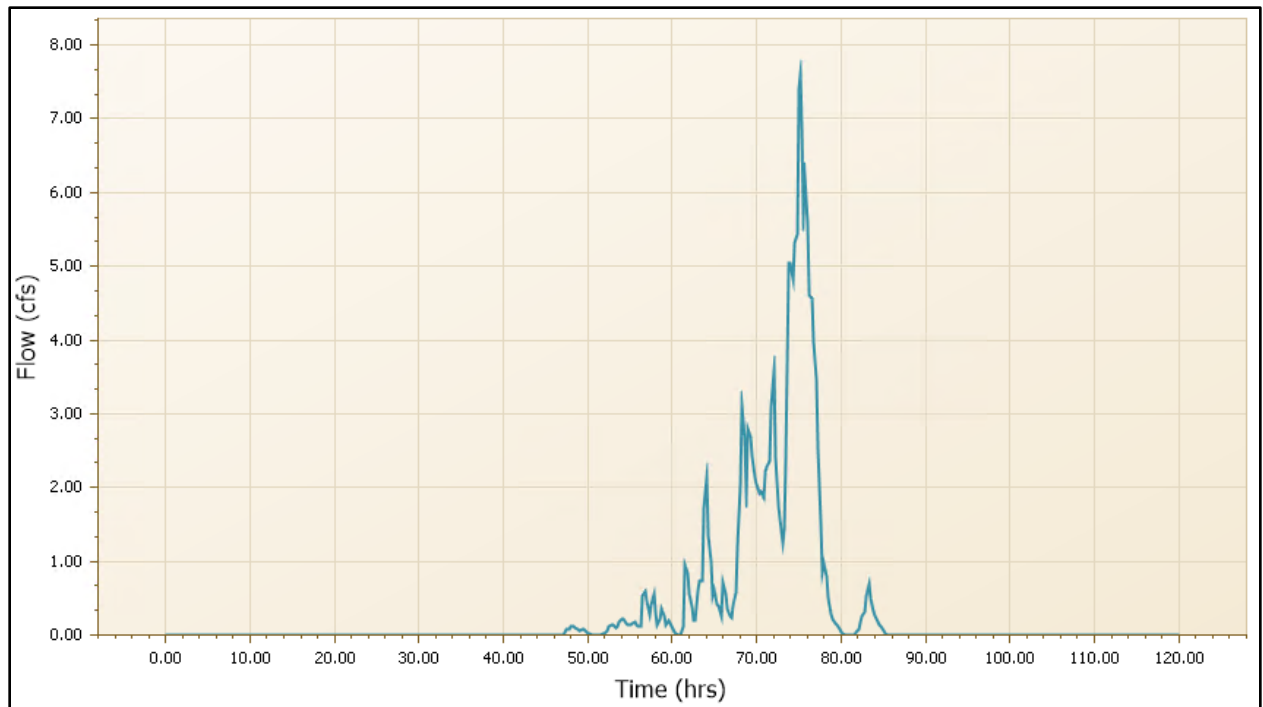
**Figure 3-1: Modeled Hydrographs Representative of Canton Avenue for the a) 100-year, 24-hour design storm and b) Hurricane Ian**

Overland flow rates during Hurricane Ian were lower than most of the design storm scenarios due to the Canton Avenue area being sensitive to the intensity of the rainfall, rather than the volume. **Figure 3-1** below shows hydrographs for the 100-year, 24-hour design storm and Hurricane Ian for basin (CRA 2020) adjacent to the overland flow region. Due the greater intensity of rainfall during the 100-year, 24-hour event, flows in this basin exceeded 16 cfs whereas they stayed below 8 cfs during Hurricane Ian.

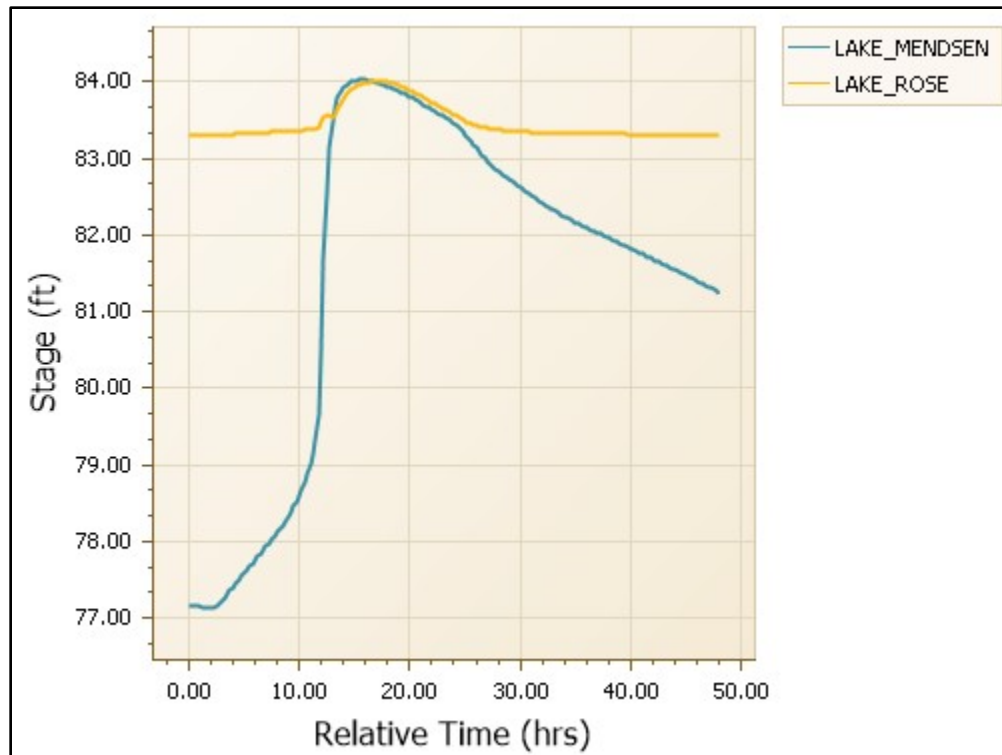
**Figure 4-1: Modeled Time/Stage Data for Lake Mendsen and Lake Rose for 2-Year, 24-Hour Design Storm**

Time/Stage data for Lake Mendsen and Lake Rose during the 2-year, 24-hour design storm event are presented in **Figure 4-1**.

As seen in **Figure 4-1**, when the stage in Lake Mendsen rises above 83.3 ft NAVD (which occurs at approximately hour 12), water begins moving from Lake Mendsen to Lake Rose. From approximately hour 12 to hour 16, water is conveyed to Lake Rose, resulting in a peak stage at Lake Rose of approximately 84.01 ft NAVD, which is approximately 2.8 ft below the top of bank for Lake Rose. After hour 16, both Lake Mendsen and Lake Rose drain simultaneously via the two existing drainwells and the interconnect to Lake Killarney, until the stage at Lake Rose reaches 83.3 ft NAVD, the elevation of the proposed weir and the lake’s assumed normal water elevation. Since Lake Rose was originally formed from a sink hole, conditions may favor relatively quick infiltration; however, this would need to be confirmed by a more detailed hydrogeologic investigation. Further investigation would be necessary to establish a normal and normal high water elevation for Lake Rose prior to pursuing this improvement alternative.
