LAKE ECOSUMMARY

Lake Virginia, June 4, 2012

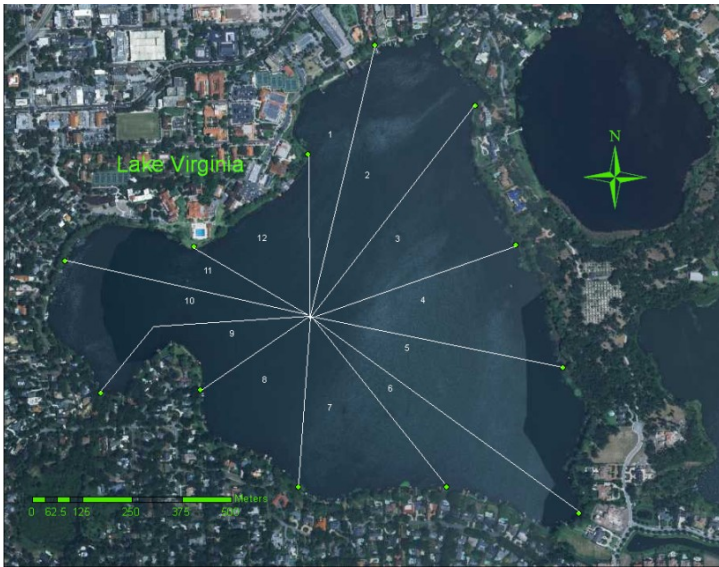
Figure 1. Sampling map of Lake Virginia. Sections 2,5,8,11 were sampled for the Lake Vegetation Index. The water quality sample was collected from the lake center.
